# Preliminary Ecological Appraisal – River Avon South West of Town Bridge

2020

Produced by Wild Landscapes of Wiltshire Wildlife Trust in Partnership  
With Chippenham Town Council

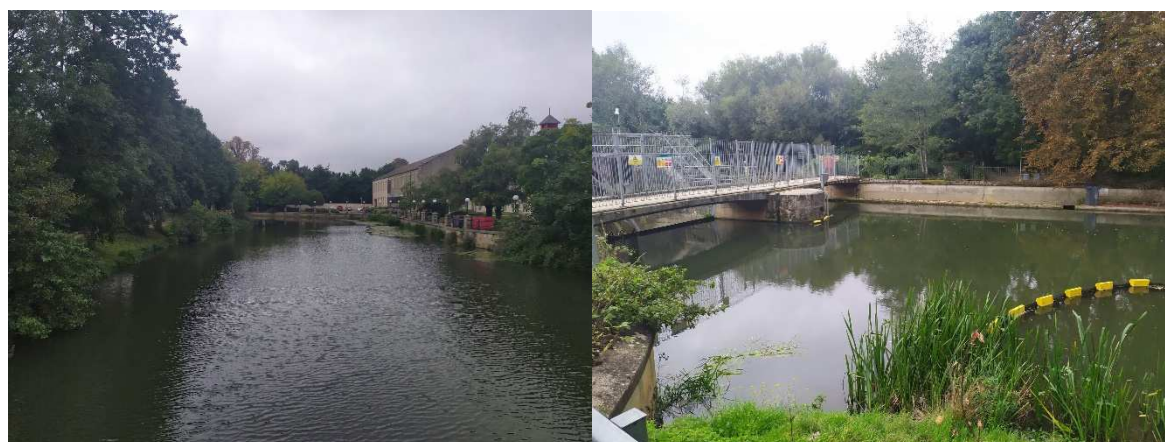
**Figure 3 & 4:** View from Town Bridge & near Weir (Authors own, September 2020)

From the Town Bridge the river, 25m wide at this point, flows westwards before turning south on the approach to the radial gate weir. On both sides the river is surrounded by commercial buildings and hospitality outlets, yet the banksides are lined with numerous trees, shrubs and reeds. The river here is wide and slow flowing.

It is recommended that the area of bank in question be landscaped to create tiers which can then be formally planted and managed with native wildflowers and shrubs. This will discourage people from feeding the birds there and create a more pleasantly aesthetic area.

It is important to provide an alternative option for people to feed the birds otherwise the issue will be recreated somewhere else. It is recommended that either a bird seed dispenser be installed on the bridge or local businesses near the bridge sell bird seed as part of a community initiative. In addition to this information signage should be installed on the bridge to let people know the importance of feeding the right food, where they can get it and that they can only feed the ducks off the bridge. This method has proven effective in other locations where larger businesses have sponsored the sale of the bird seed to contribute to the protection of the river.

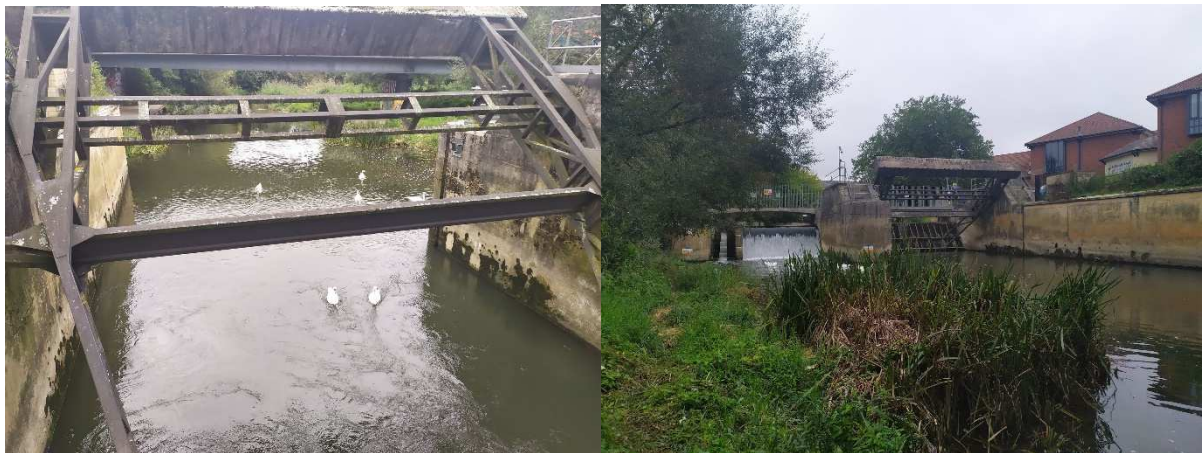
**Figure 5 & 6:** The Radial Gate Weir (Authors own, September 2020)

At this point the River Avon is bisected by a large, concrete, radial gate weir that forms part of the Chippenham Town flood defences. On the far side of the weir there is a concrete fish pass and a small foot bridge crosses the weir structure. At the bottom of the weir is the junction with the Avon of Hardenhuish Brook, which flows in from the north. Then the river flows under Gladstone Road Bridge, the underpass of which contains a graffiti wall. This area is prone to severe flooding in winter.

The radial gate is owned by Environment Agency and performs two functions. Firstly, it creates an impoundment during normal flow conditions and secondly, it manages flood risk by opening during high flow conditions.

*"The Environment Agency are currently investigating options for long term replacement of the radial gate and adjacent weir. We are keen to work with partners to explore what the preferred option may be here. Rather than just look for a like to like replacement, we would like to investigate the opportunity to make more significant changes here, and ideally look to remove the gate and weir entirely."* (Whittaker, 2020).

Whilst this project will undoubtedly take many years to plan and execute, and involve lengthy consultation with a variety of local stakeholders, the environmental and ecological benefits to the River Avon can be high. However, there is also the possibility that weir removal will increase some ecosystem services at the expense of others.

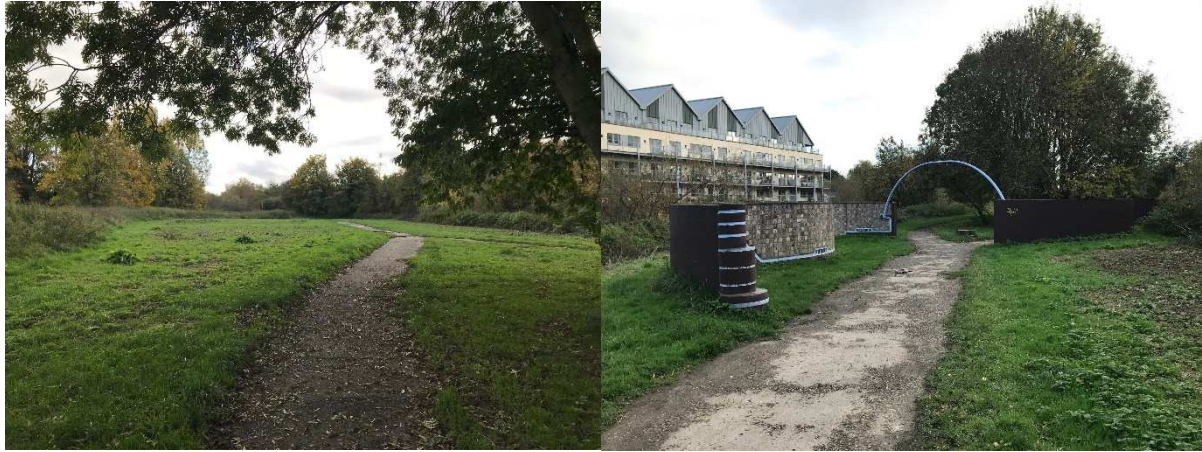
**Figure 7 & 8:** Avon Valley Path & Millennium Wall (Authors own, September 2020)

This is the longest section of the site. The river, which is narrower here, flows south from Gladstone Road Bridge until it reaches the foot-bridge at Westmead, an area owned by Chippenham Borough Lands Charity. Avenue La Fleche bypass runs above the river to the west and retirement apartments are situated to the east. The river here is flanked by a riverside path containing areas of grassland, scrub, a small copse of ash trees and also the Millennium Wall, constructed by local school children. The area is prone to flooding and the river banks are dominated, in places, by Himalayan balsam (*Impatiens glandulifera*).

The grassland around the area of the millennium wall is part of the river route and the path verge is cut every 2-4 weeks depending on conditions. The larger areas have walkways cut in a variety of places, then the remainder has is cut on a twice a year schedule.

Broadly, the management schedule should continue in its current form. The area is prone to seasonal flooding and any change of management would need to take this into account. Within the cutting regime a 2m buffer zone should be introduced to protect the bankside riparian habitat. Details of bankside habitat management can be found within the proposed Monkton Park Management Plan document.

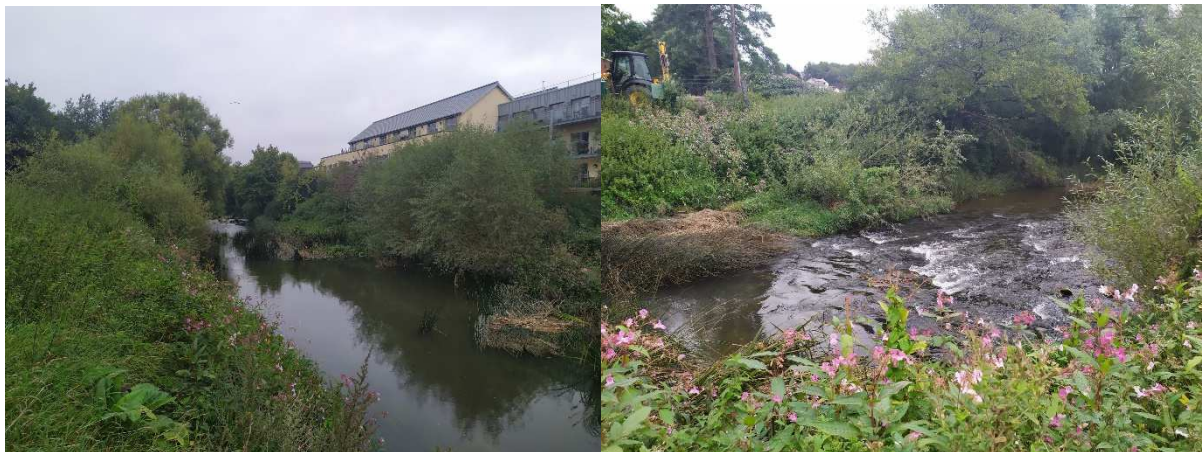
**Figure 9 & 10:** River Avon & Himalayan Balsam (Authors own, September 2020)

In general the riparian habitat along this stretch is adequate with a good mix of dense vegetation, including trees, along the entire section. However, large swathes of Himalayan balsam dominates the sward along parts of both banks.

This non-native plant can be invasive because it spreads quickly and forms dense thickets that alter the ecological balance and character of the riverbank. Many seeds drop into the water and can contaminate the riverbank further downstream, but the explosive nature of its seed release means it can also spread upstream too. It produces a lot of pollen over the growing season and is attractive to pollinating insects, but there is concern that its presence may result in decreased pollination for native plants.

Himalayan balsam needs to be dealt with before it sets seed. If control is undertaken early enough to prevent flowering then eradication is possible in two or three years. The plant is shallow-rooted and can be pulled out and disposed of by composting carefully, or by burning if seeds are present. If this is done on a regular basis and the plant is not allowed to set seed, it will eventually die out. Regular strimming of larger areas is also an option, as long as it is done often enough to prevent flowering.

The steep sided banks along this stretch of the river may preclude all plants from being pulled from the bankside and there is scope for plants to be removed from within the river itself depending on depths and availability of equipment. In addition to this, the ideal solution would stipulate removal of all plants from both banks. Partnership working with the organisations that own the retirement apartments on the east bank would be required for this to be achieved.

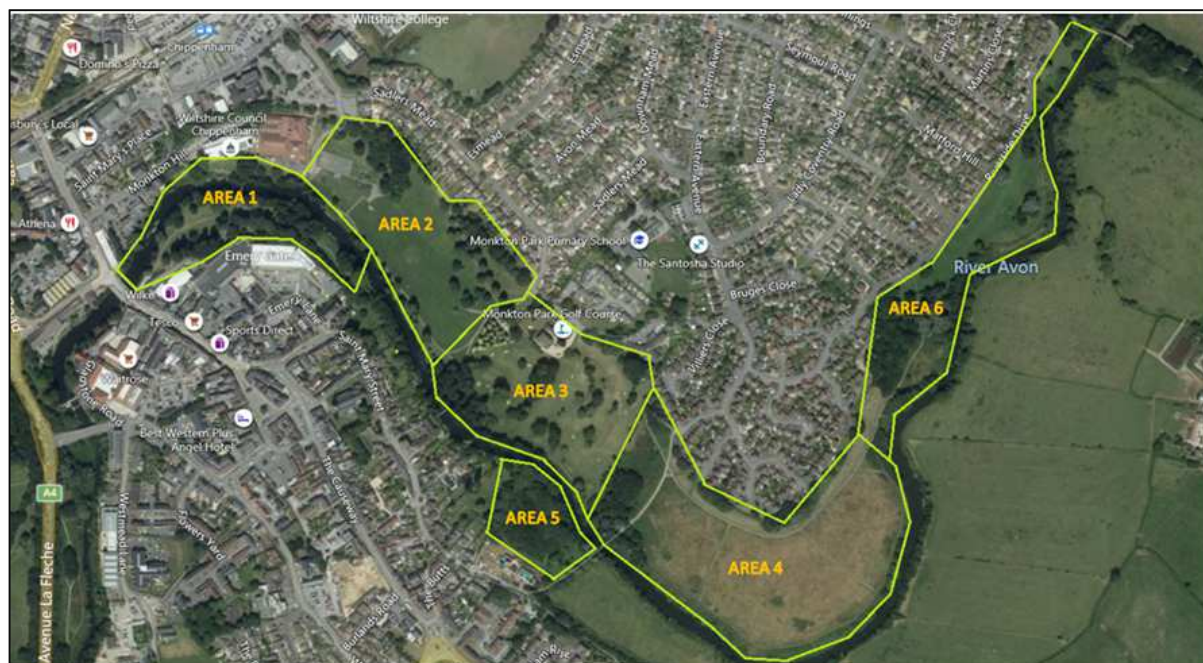
Figure 1. Site map showing the River Avon through Monkton Park with areas marked out for reference.

An advisory visit was requested by Wild Landscapes to inform a management plan they are writing for Monkton Park, on behalf of Chippenham Town Council (figure 1). Wild Landscapes engaged the specialist services of the Water Team to report on opportunities for habitat improvements to the River Avon in-channel and riparian zones.

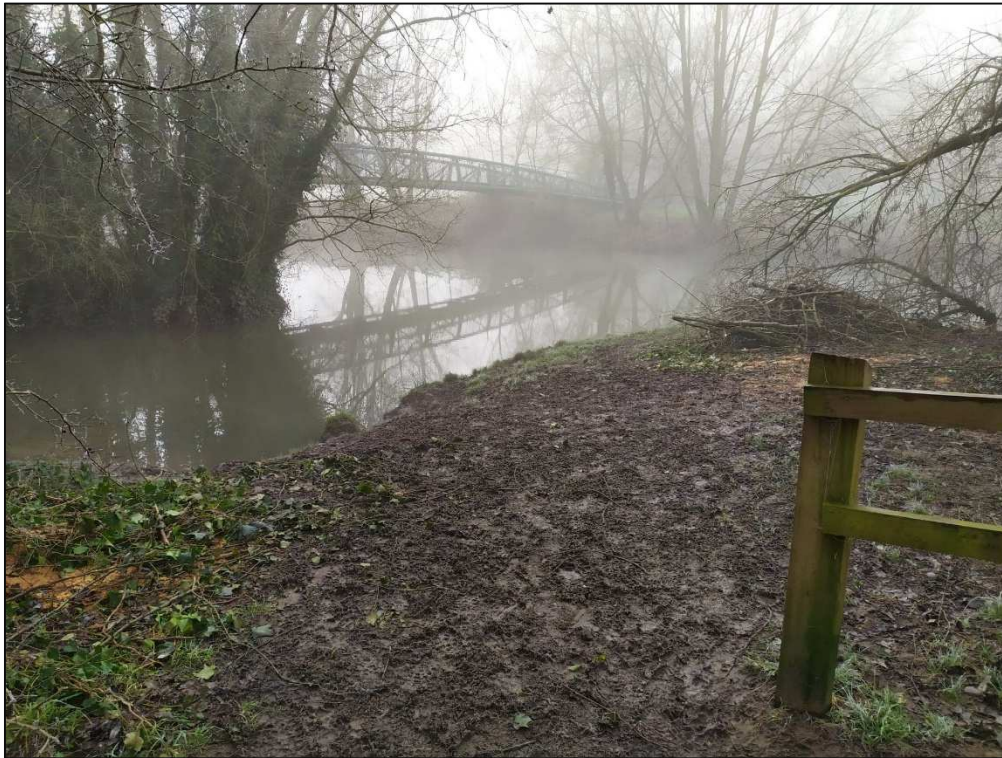
*Figure 2. Bank erosion at ST 92417 73216 where there is opportunity for the creation of a pocket park.*

Some sections of the riverbank are being eroded by people and dogs accessing the river. As there is no formalised area for this, disturbance is happening all along the riverbank. It is recommended that formalised areas for access to the river be created through the Park.

The true left bank at ST 92417 73216 appears to be a heavily used spot (Area 3 and figure 2). This provides the perfect opportunity to create a formalised access area for people and dogs. A horseshow shaped 'pocket park' could be created, with gravelled steps cut into the bank preventing soil erosion and benches installed to make it a relaxing place for families to visit and picnic in summer months. At this site there is also a back-water area, it is over-shaded with willow preventing the growth of wetland species. It is recommended that the willows be pollarded (and then again on a 5 year rotation), this will allow reed bed habitat to colonise and the wood can be utilised in the creation of the gravel steps.

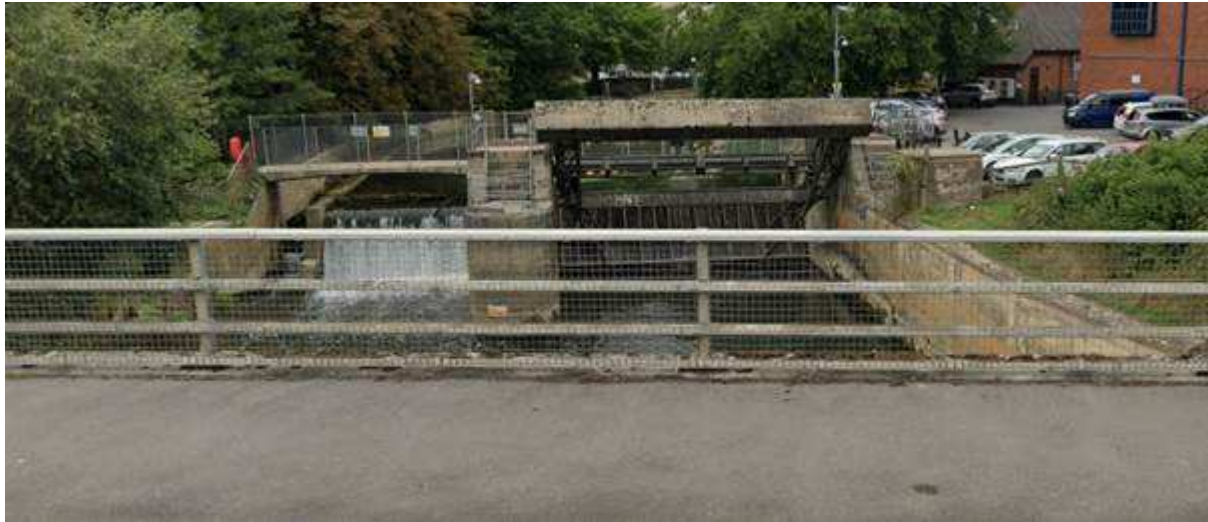
A flood defence scheme was constructed in the 1960s on the River Avon through Chippenham consisting of re-construction of the river channel through the town centre and construction of the Chippenham Gate (radial gate with side weir and fish pass) to control upstream water levels. The purpose of the gate is to retain water levels during low and medium flows for amenity purposes whilst enabling high flows to pass through the structure, reducing the risk of flooding. The radial gate has however become increasingly unreliable and is nearing the end of its residual life. In this current asset state, there is a risk that the structure will fail in a closed position, requiring Environment Agency operatives to undertake a manual lifting procedure, with health and safety issues associated with this.

The flood risk to Chippenham if the gate operates correctly is relatively low. However, if the gate was to fail to open in a flood event then the flood risk would substantially increase, especially at frequent flood events. This is a very real risk as the gate is increasingly needing manual intervention to allow it to function properly.

There are also regular issues with the gate not closing fully after a flood event, leading to a drop in upstream water levels. This leads to visual, amenity, biodiversity and safety issues within the upstream river channel.

The Environment Agency are currently investigating options for long term replacement of the radial gate and adjacent weir. We are keen to work with partners to explore what the preferred option may be here. Rather than just look for a like to like replacement, we would like to investigate the opportunity to make more significant changes here, and ideally look to remove the gate and weir entirely.
